Breakout Board Errata Memo

ECE 492 - Spring 2015

Latest Revision: 5 May 2015
Prepared By: Katherine Nellis

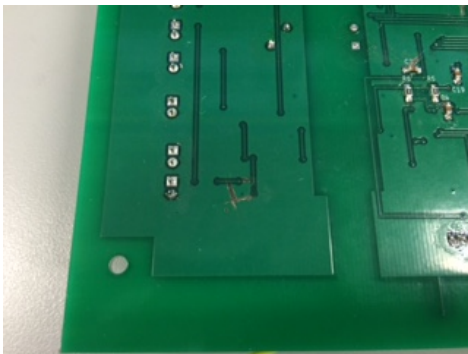
Figure 1. Errata 1.

1. Isolation of the through hole near U6 and L2.
2. Isolation of the through hole near C2.
3. Isolation of multiple through holes near U1, U8, and U11.
4. Missing connection between U17 the AMS I2C port.

NOTE: All errata have been corrected in the most updated versions of the Gerber files and schematics for the BoB, as well as having been physically fixed by William Stathis on the working BoB used in LFEV TSV 2015's system. Ordering new boards for future use will require no changes to be made; however, if future teams wish to utilize the 4 boards we purchased in 2015, these errata should be handled.
