Working Errata for SegMan
03/25/2019
Hayden Dodge

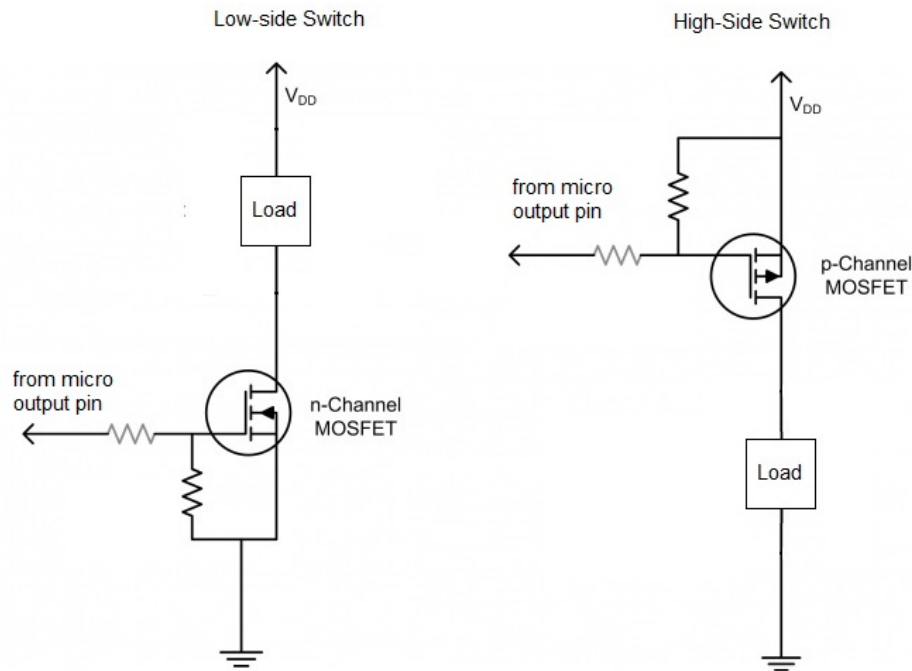
1. Q1 is an N-channel Mosfet and it is currently configure as a high side switch. This will not work. Configure this a low side switch to drive the Charge Relay.
