Edits Made to TSI Rev.6 Board for Next TSI Revision

5/11/21 - TC, JB

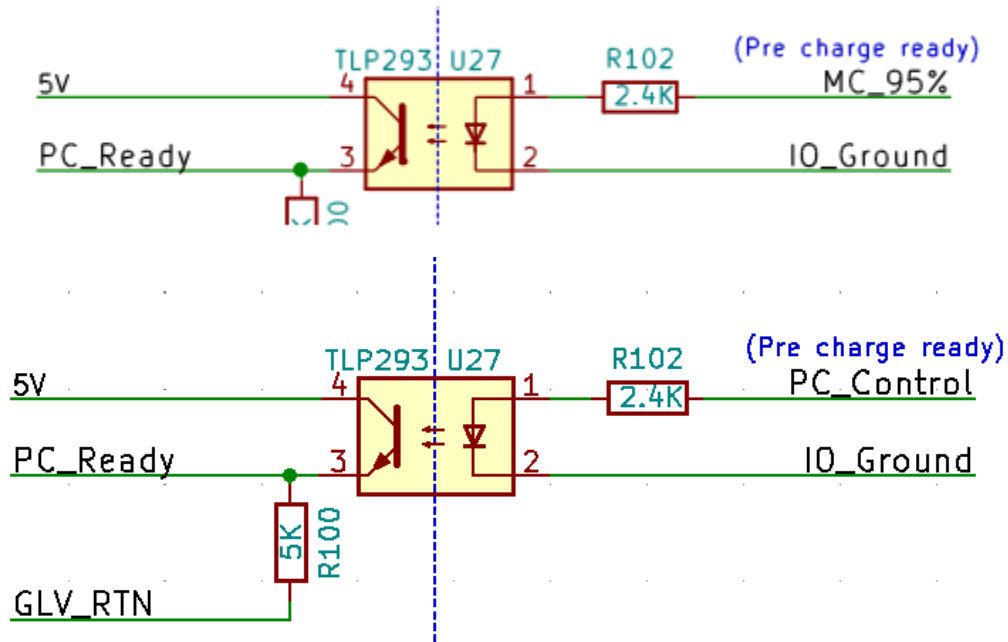
1. MC_95% Signal should actually be PC_Control as seen below, flywire needs to be added to board. This is an artifact from TSI Rev. 4's board. They had two separate pre charge ready signals, they were "Precharge Ready" and "Pre charge Ready." We thought this was a mistake and removed the "pre charge Ready" signal from the schematic. Thus leading to the current confusion. (edits made on TSI schematic and pcb schematic)

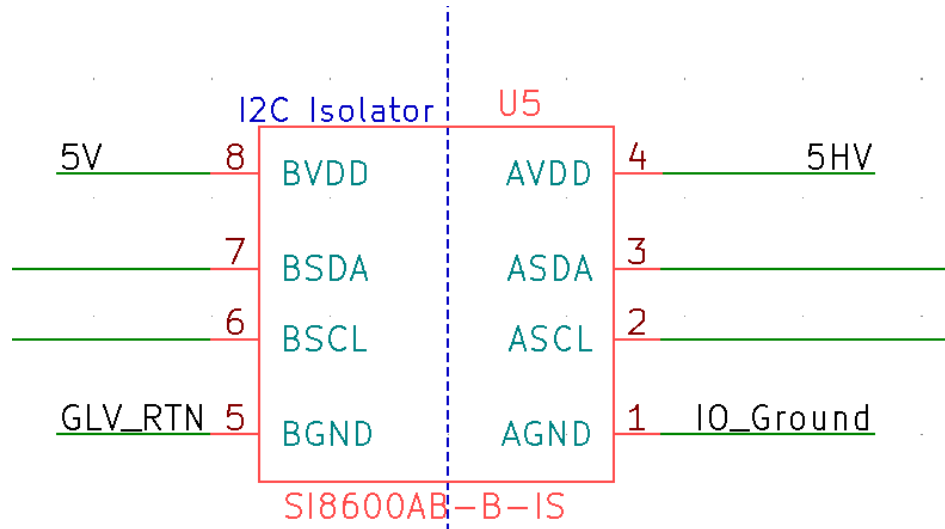
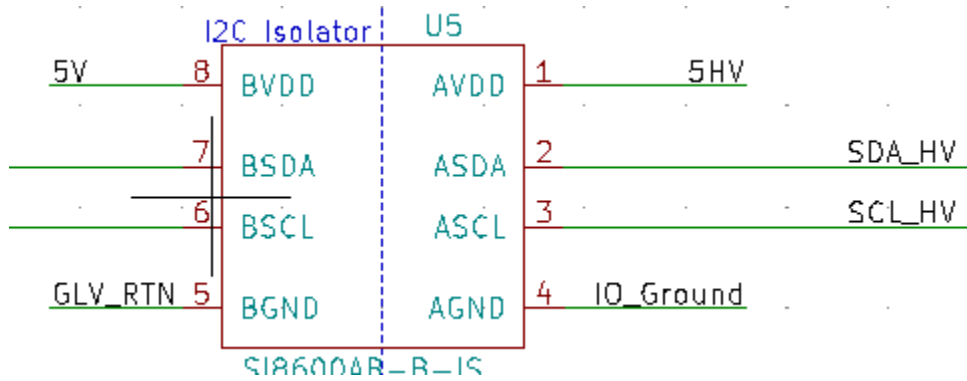
1. Symbol for U5, SI8600AB-B-IS was wrong. (Fixed on schematic and rerouted on pcb schematic, flywires applied).

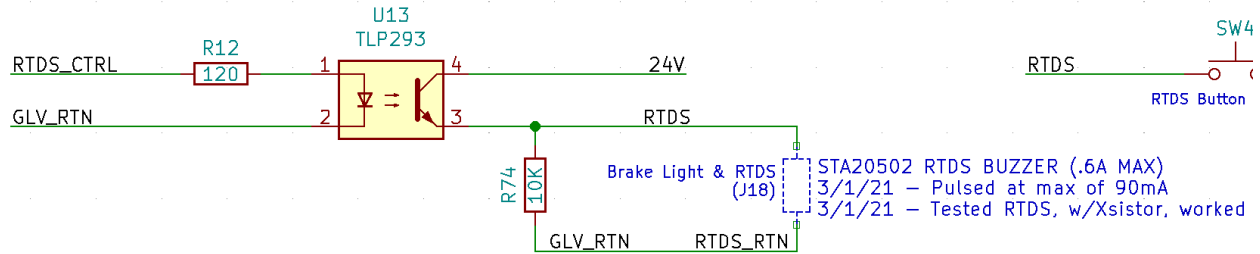
1. RTDS TLP (U13) gets very hot if RTDS is left on too long. Not an issue we were concerned with because technically RTDS should be only on for about two seconds. Could be remedied in later design.

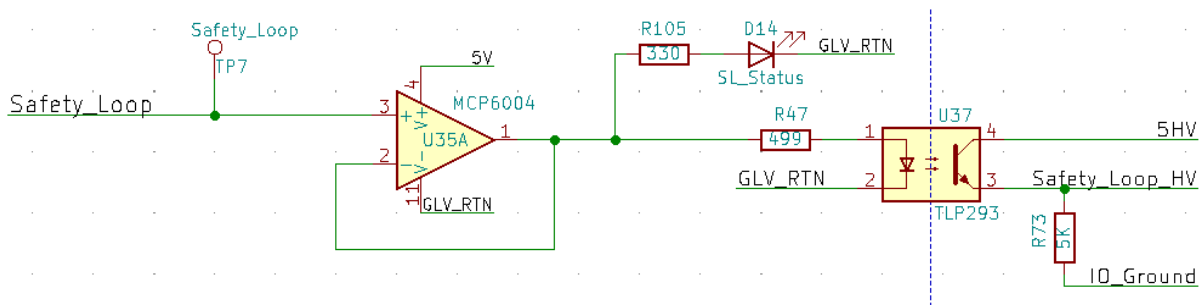
2. Changed U35A's rails from 3.3V to 5V

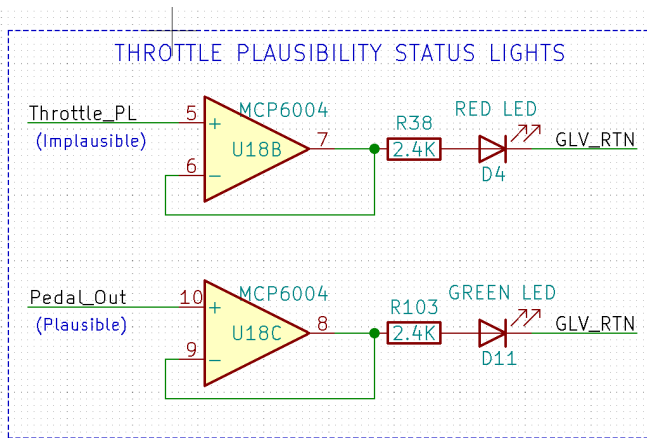
D4 on backwards or burned out. To drive D4 and D11, should not use the actual throttle_pl and Pedal_out signals. Example: as when pedal_out is around a volt (you're driving the throttle voltage of the motor) the LED doesn't come on.

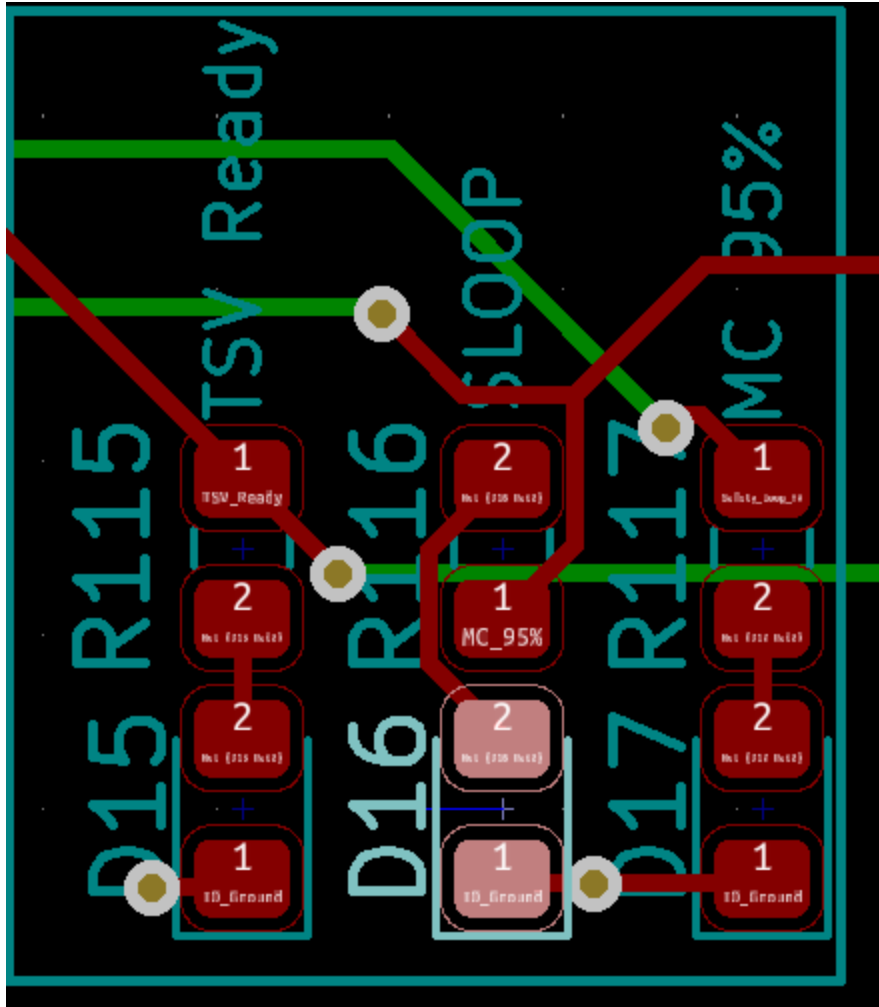
On the actual board, the silkscreens are flipped for D16 and D17. D16 is MC 95%, and D17 is SLOOP in actuality.
