Edits Made to TSI Rev.6 Board for Next TSI Revision

Note: things in red are unresolved.

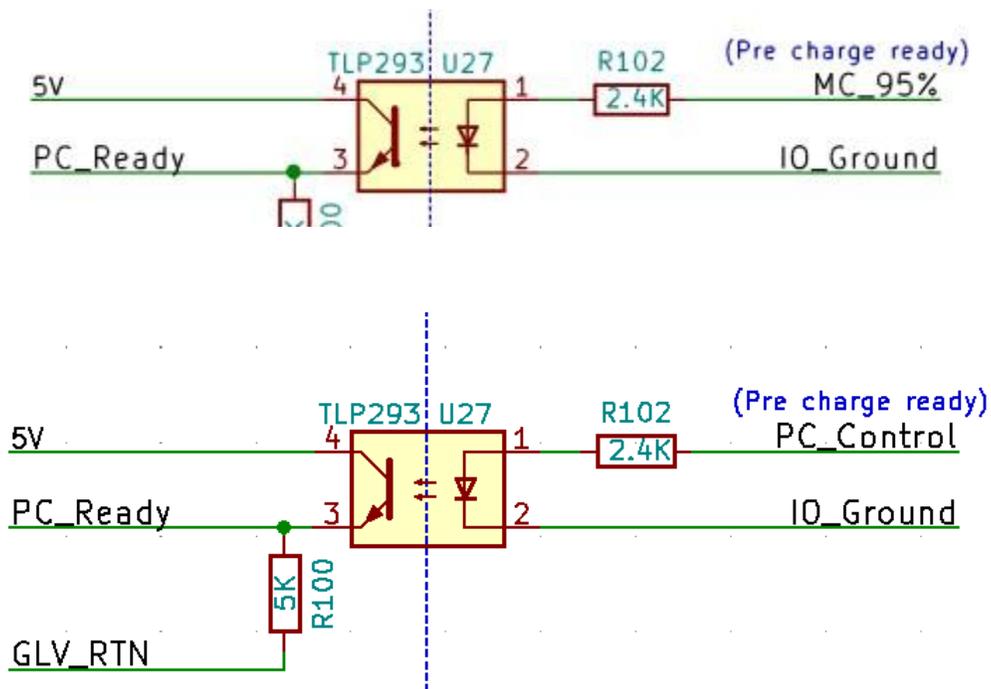
1. MC_95% Signal should actually be PC_Control as seen below, flywire needs to be added to board. This is an artifact from TSI Rev. 4's board. They had two separate pre charge ready signals, they were "Precharge Ready" and "Pre charge Ready." We thought this was a mistake and removed the "pre charge Ready" signal from the schematic. Thus leading to the current confusion. (edits made on TSI schematic and pcb schematic)
2. 10/14/21 – EC – Flywire added to board. This issue has now been resolved.

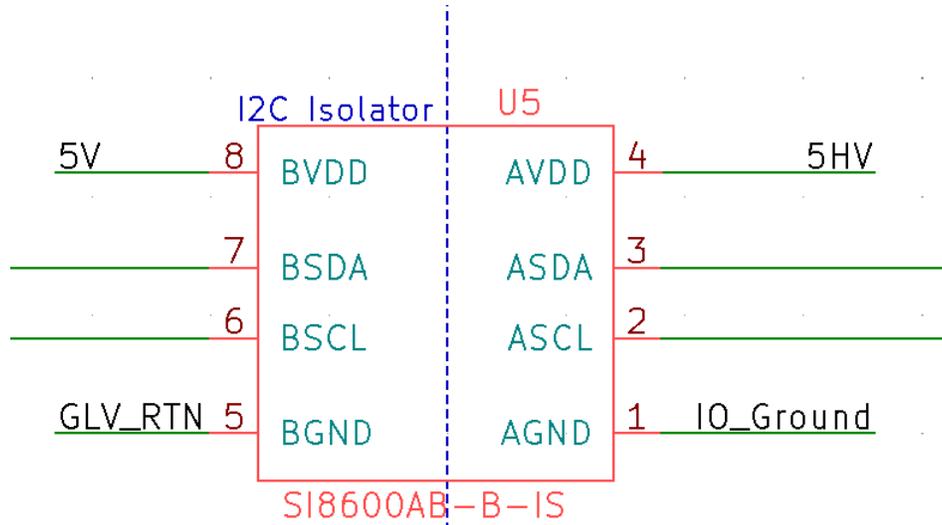
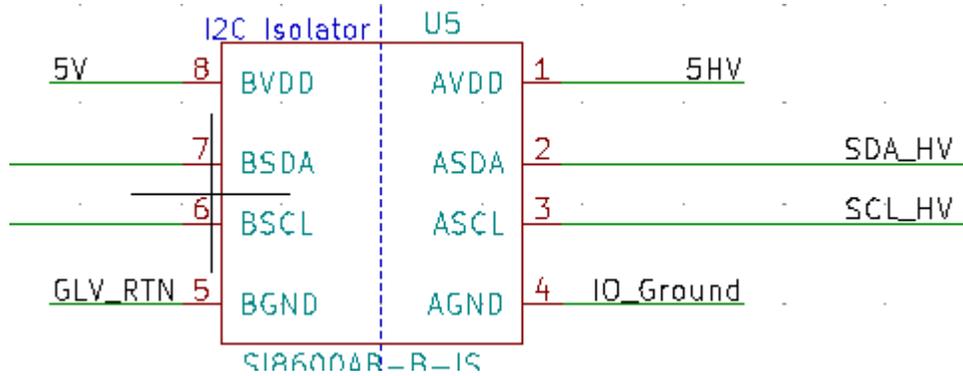
1. Symbol for U5, SI8600AB-B-IS was wrong. (Fixed on schematic and rerouted on pcb schematic, flywires applied).

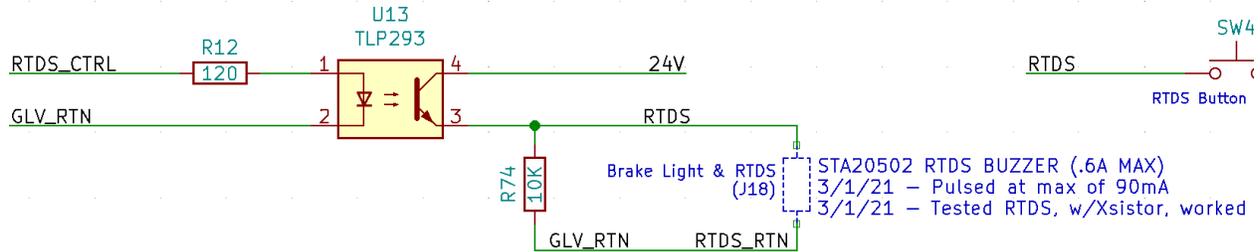
1. RTDS TLP (U13) gets very hot if RTDS is left on too long. Not an issue we were concerned with because technically RTDS should be only on for about two seconds. Could be remedied in later design.

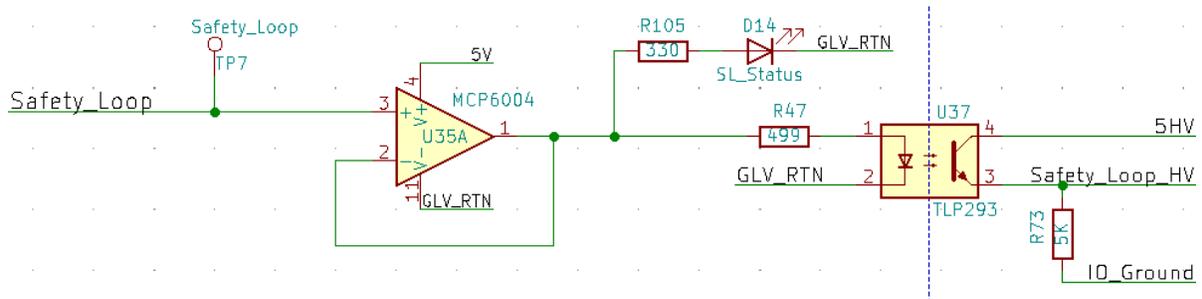
2. Changed U35A's rails from 3.3V to 5V on schematic
3. 10/22/21 – EC – Cut connection to 3.3V and added flywire to 5V on the board. Change needs to be made on PCB Layout

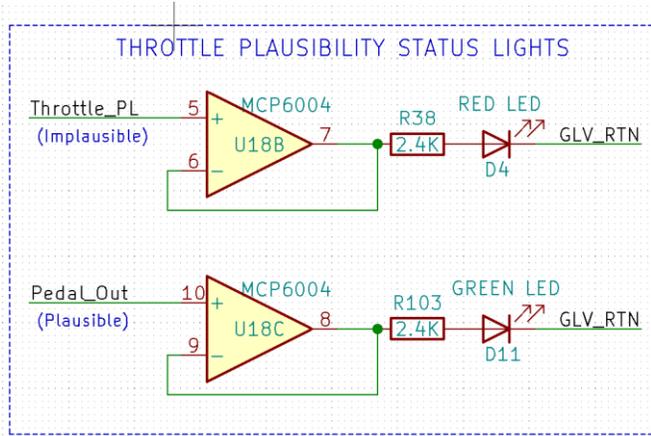
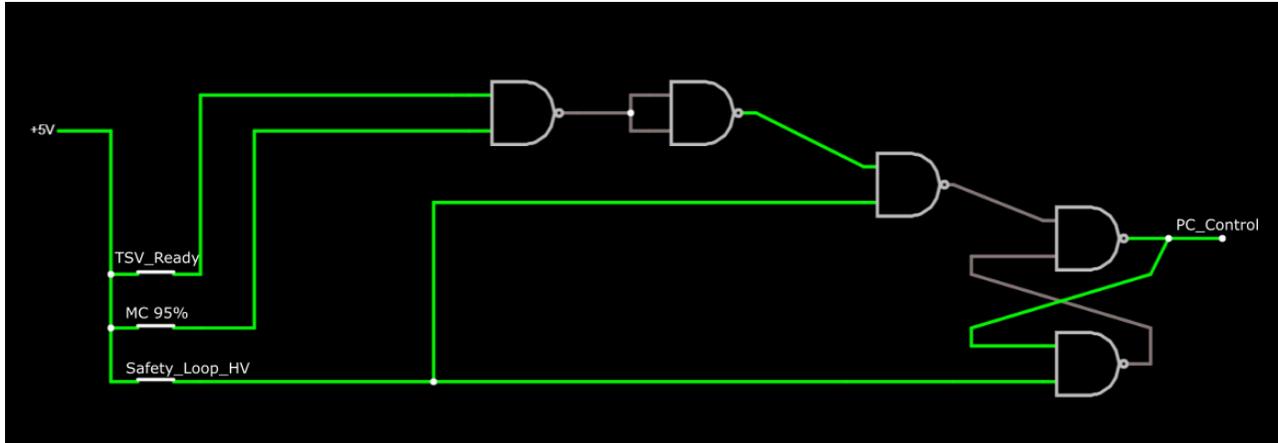
D4 on backwards or burned out. To drive D4 and D11, should not use the actual throttle_pl and Pedal_out signals. Example: as when pedal_out is around a volt (you're driving the throttle voltage of the motor) the LED doesn't come on.

10/26/21 – EC – D4 replaced on the board. Driving it with Throttle_PL is in fact fine since it is the output of an AND gate and thus will be 5V when the D4 is supposed to turn on. D11 doesn't actually seem to serve much purpose and could be removed in a later revision since we don't care whether Pedal_out is on or off, we care about its actual voltage. If anything, U18C's inverting terminal could be connected to a .24v reference so that D11 turns on whenever Pedal_out is in it's .24V to 4.76V range, and turns off when Pedal_out gets shorted to ground (which happens when the throttle is determined to be implausible)

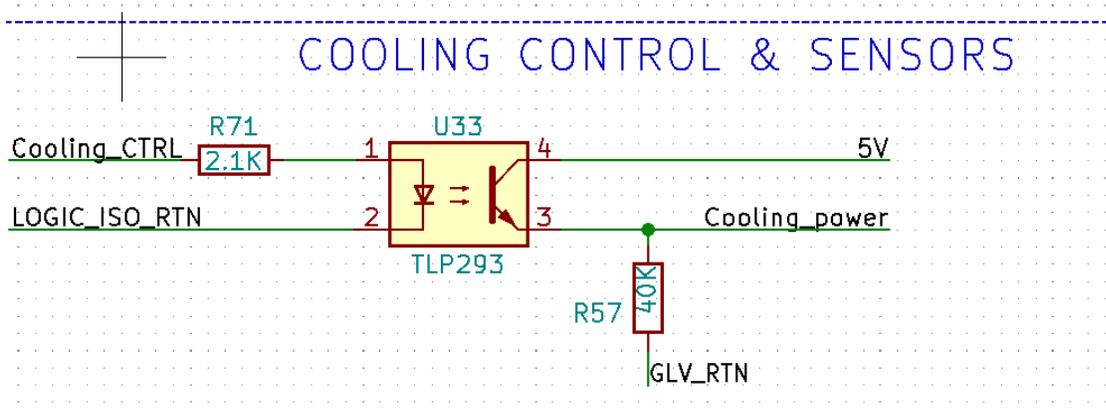
R57 needs to be replaced with a 2.2kΩ resistor. (Change made on board, not yet made on PCB Layout or Schematic). Although the schematic says 40k, the resistor was actually 5k which was still too high. When cooling_CTRL was logic low, we measured a leakage current of 0.32mA through pins 4 to 3, causing Cooling_power to be 1.6V ($0.32\text{mA} \times 5\text{k} = 1.6\text{V}$), which was enough to turn on the cooling system (since cooling_CTRL was low, should have been off). When cooling_CTRL is high (3.3V), we measured 2.14mA through pin 4 to 3. We thus 2.2kΩ since it is enough to turn on the cooling system ($2.2\text{k}\Omega \times 2.14\text{mA} = 4.7\text{v}$) when we want, but low enough to keep it off even with the leakage current ($2.2\text{k}\Omega \times 0.32\text{mA} = 0.7\text{v}$)
