**Department of Civil and Environmental Engineering
Lafayette College**

**CE473 – Senior Capstone Design II
Spring 2015**

Geotechnical Engineering Study and Design Report for “Elevating Easton” Project

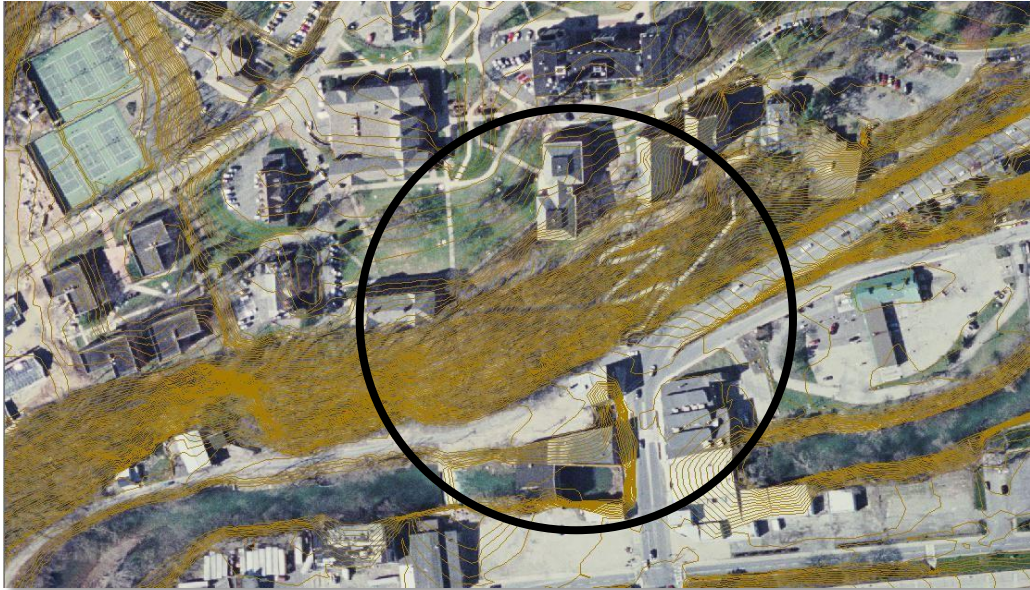
Figure A3. Aerial photograph with LiDAR contour elevations. Contour information and photograph provided from CE 472

The site has a water table elevation of typically 163.5 feet above sea level. Similarly, Aerial LiDAR data utilized by the CE 473 Capstone Design II course at Lafayette College references a Bushkill Creek elevation of 164 feet above sea level. It is important to note that the elevation of the water table changes with time and space and is influenced by the time of the water year and precipitation.

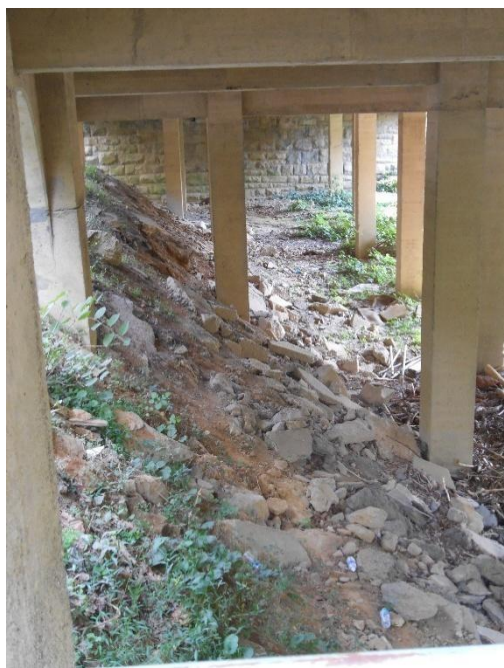
Figure C3. Image of foundation under 3rd Street bridge, adjacent to The Spot.

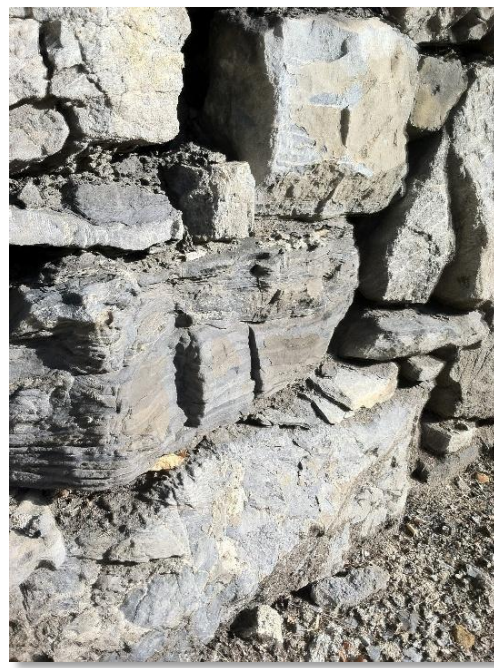
Figure C4. Image of rocks forming the foundation of the retaining wall along College Avenue and Bushkill Drive.

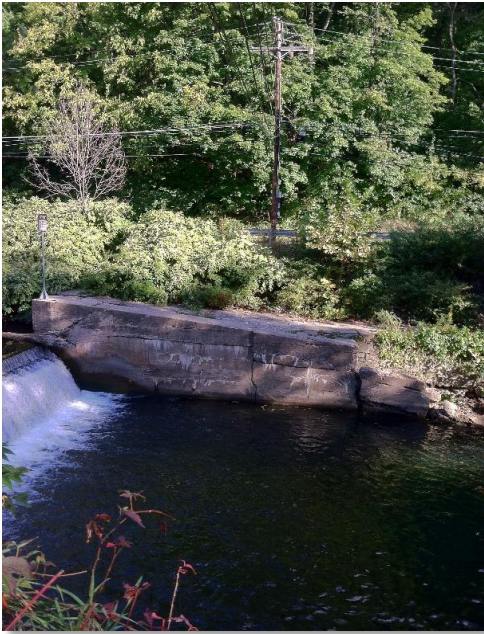
Figure C5. Image of Bushkill Creek walls, fractures visible.

Site reconnaissance was completed through the field exploration; please refer to Appendix C – Field Photographs for the field photographs of several field explorations and observations. Our team noticed a slope comprised of diverse fill materials under the N. 3rd Street Bridge, adjacent to The Spot. Large chunks of concrete, rocks and other debris jut out of the slope face (Figure B1). To the west of this slope and adjacent to a small dam, the south side wall of the Bushkill Creek exhibits many fractures and deterioration (Figures B5 and B6).

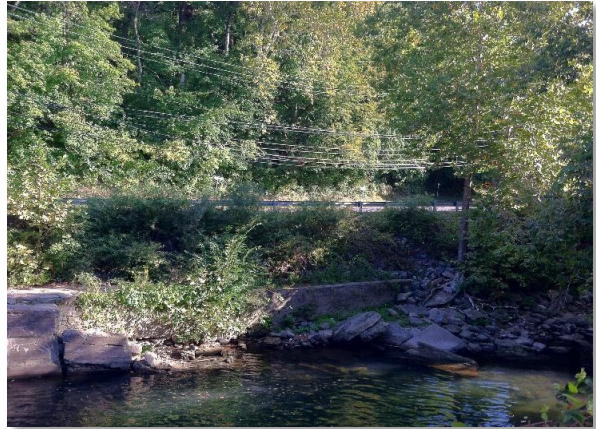
Figure C6 Another image of Bushkill Creek walls, fractures visible. Parking area to the west of The Spot visible in the upper right.

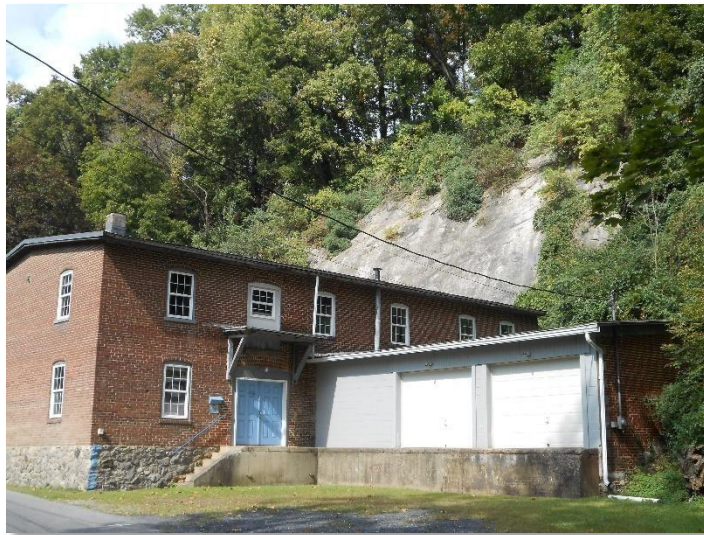
Figure C7. Image rock outcrop to the west of site location, north of the Bushkill Creek.

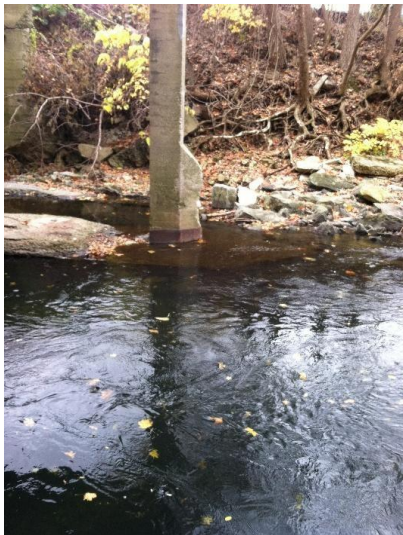
Figure C10. Scour formation under 3rd St. Photo taken November 7th.

Minor scour of the Bushkill Creek riverbed was observed during site reconnaissance. Minor deterioration of the existing retaining wall was also observed. No remediation of these structures is recommended since there are no proposed slabs on grade for the SPOT Landing location and it is recommended that foundation support is provided by micropiles.

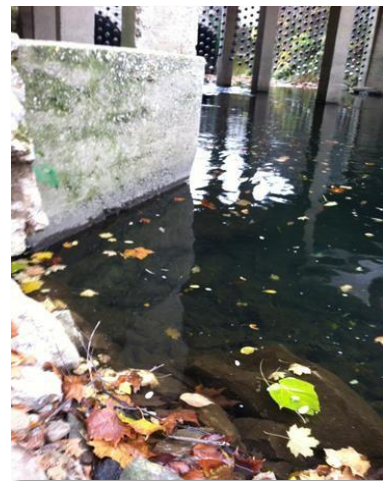
Figure C11. Scour formation under Bushkill Creek retaining wall. Photo taken November 7th.

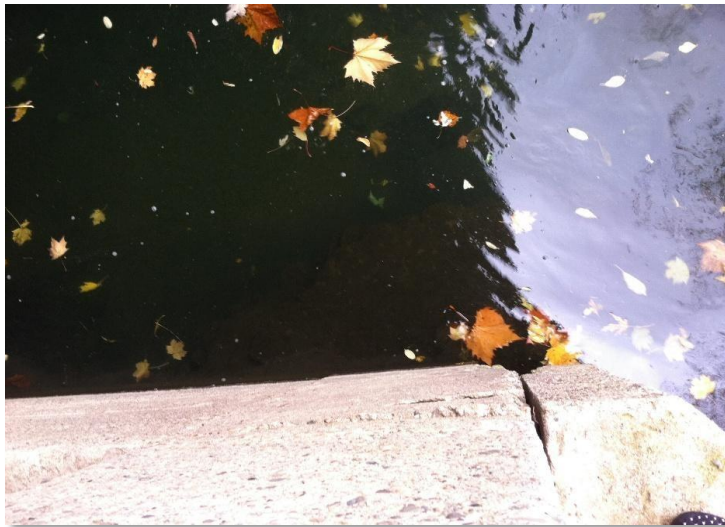
Figure C12. Scour formation under Bushkill Creek's north retaining wall. Photo taken November 7th.

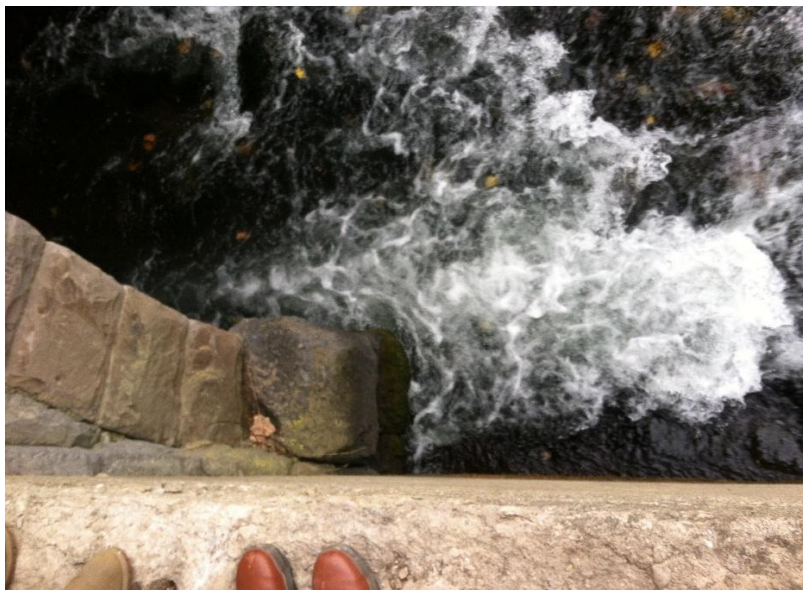
Figure C13. Potential scour formation under N. 3rd St. Bridge. Turbulent river flow hides view. Photo taken November 7th.

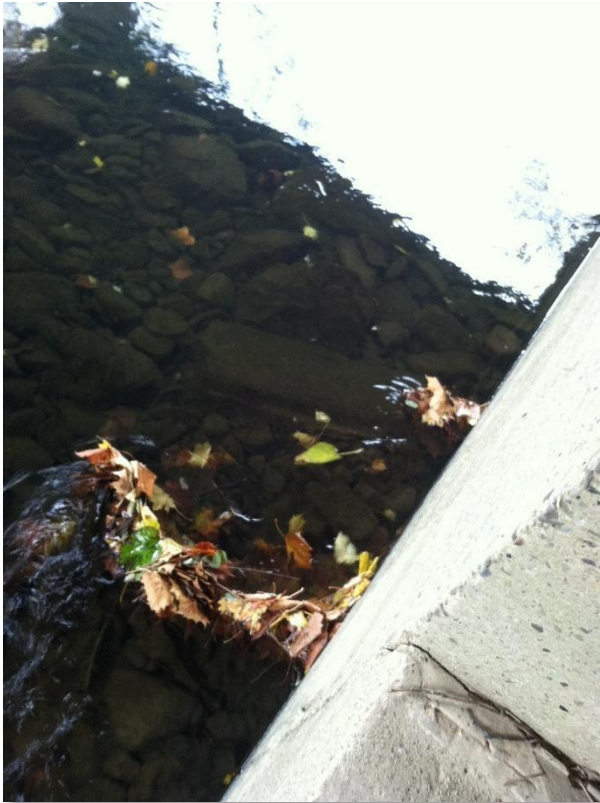
Figure C14. Potential scour formation undermining retention walls of Bushkill Creek. Photo taken November 7th, 2014.

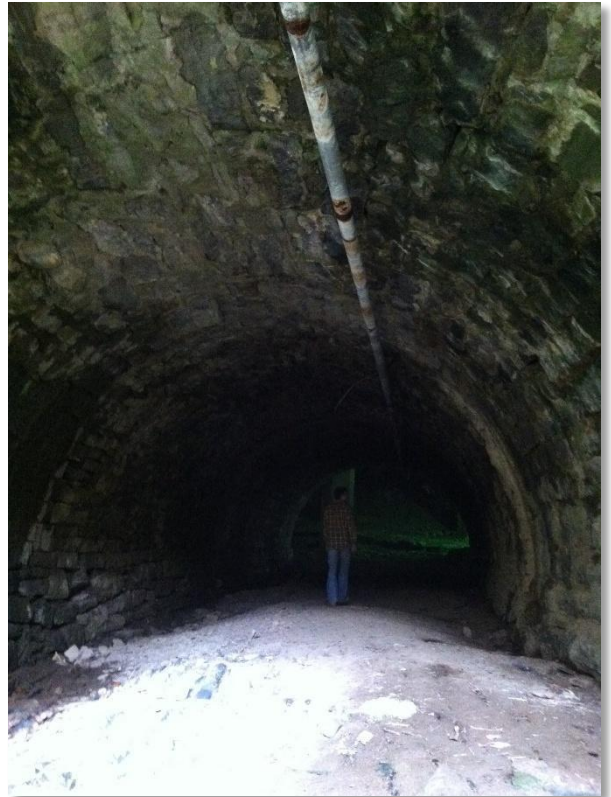
Figure C15. Fractures underneath N. 3rd St. Bridge structure. Leaking water visible. Photo taken November 7th.

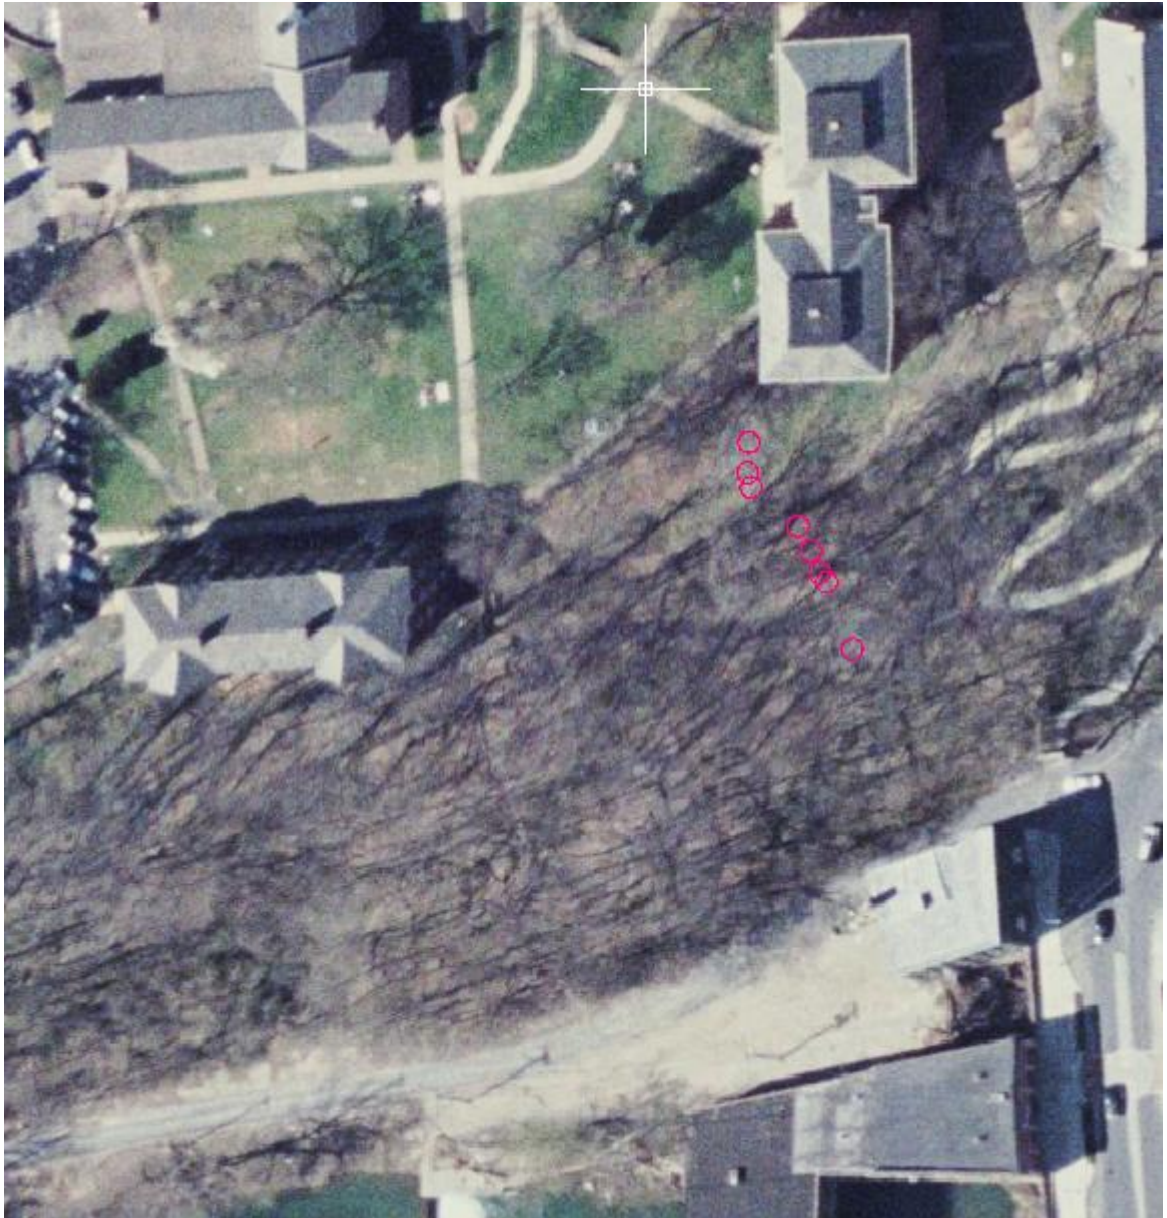
Figure E1. Boring Location Map. Pink circles indicate hand auger boring locations on the slope.

locations of these borings are shown on the aerial map in Appendix E- Boring Location Map. Please see Figures B21 to B23 for photographic representation of this boring log field work.
