**ENVIRONMENTAL SITE ASSESSMENT OF
THE PROPOSED BUSHKILL CREEK
3RD ST. DAM REMOVAL**

December 17, 2010

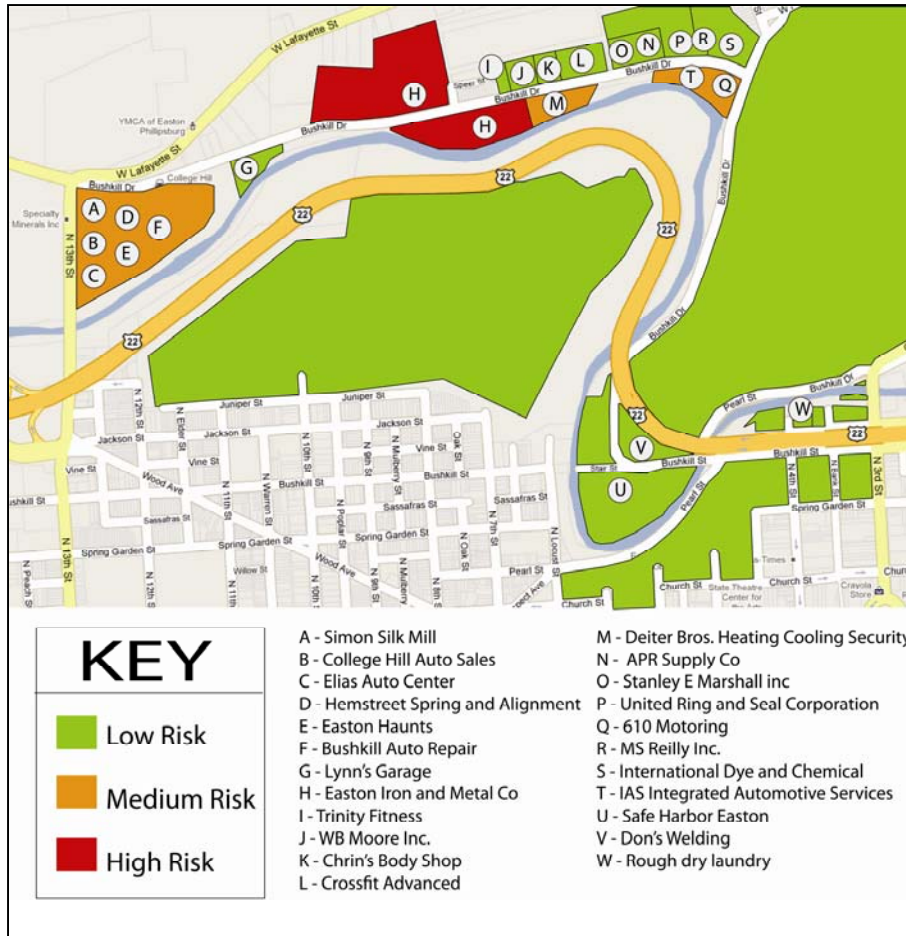
Figure 3.2.1 – Map of Sites within 3rd to 13th Area of Interest

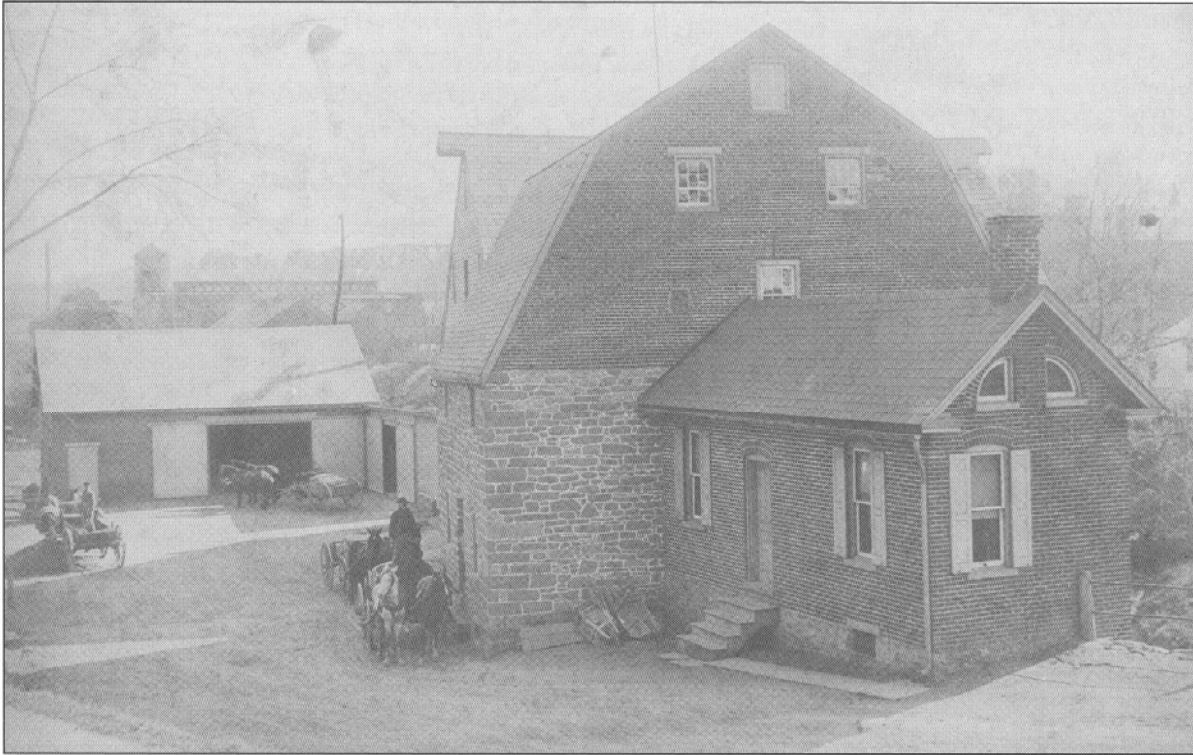
Appendix B.2 – Mann and Allshouse Feed Company

This is a circa 1900 view of the Mann and Allshouse Feed Company, 240 Bushkill Drive. Presently this is the sight of Easton Shammy Shine Car wash.

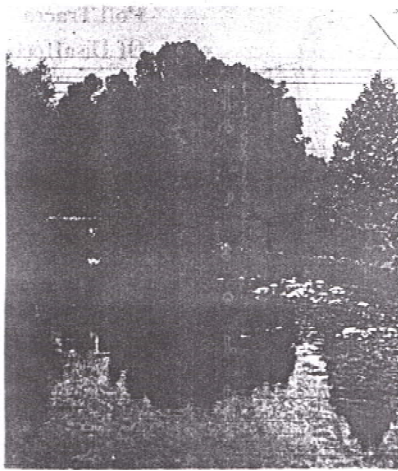
SCENE — In the upper part of the Bushkill Creek, the quiet beauty of the area is still evident. Full and heavy shrubbery provide the shade to keep the stream's temperature high for trout.

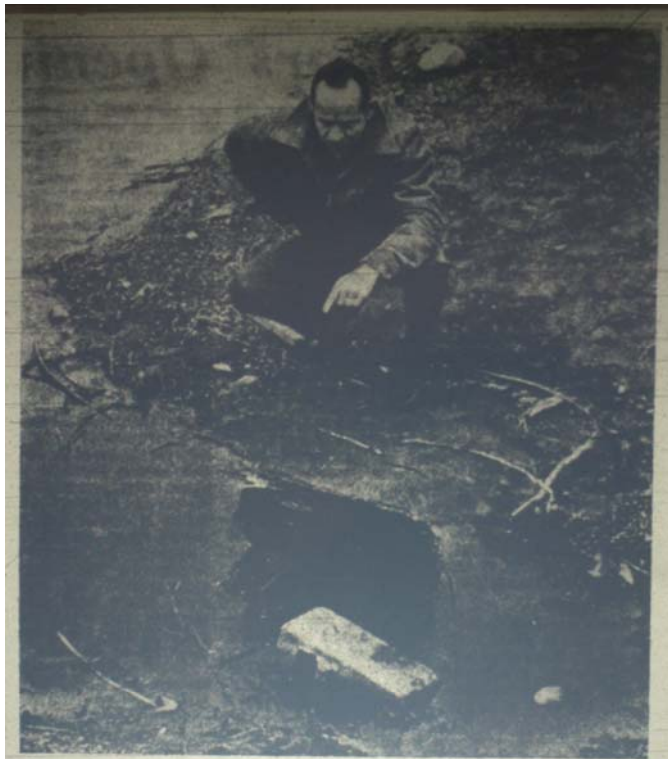
Appendix C.9 – Easton Express Times Article

BUSHKILL CREEK OIL SLICK — Paul LaBar of Tatamy points out a pool of oil slick in the Bushkill Creek near the Tatamy Bridge. Hercules Cement Plant officials say the spill occurred yesterday morning during a fuel oil delivery. Damage to the Bushkill's aquatic life is not certain. —Express Photo By Ed Koskey Jr.

Description: There was an oil spill at Hercules Cement Co. that leaked down a water drain and into the Bushkill. It was promptly cleaned up, but there was still development of oil slicks and sludge accumulations. Action will be taken if there was negligence. Damage to wildlife is uncertain.
